LIMITED CONDITIONAL STRUCTURAL REPORT

Project	Newsome Clock Tower, Newsome Mills, Ruth Street, Newsome, Huddersfield, HD4 6JF
Project Number	2020/083
Date	27th February 2020

Structural Conditional Report on Newsome Clock Tower, Newsome Mills, Ruth Street, Newsome, Huddersfield, HD4 6JF

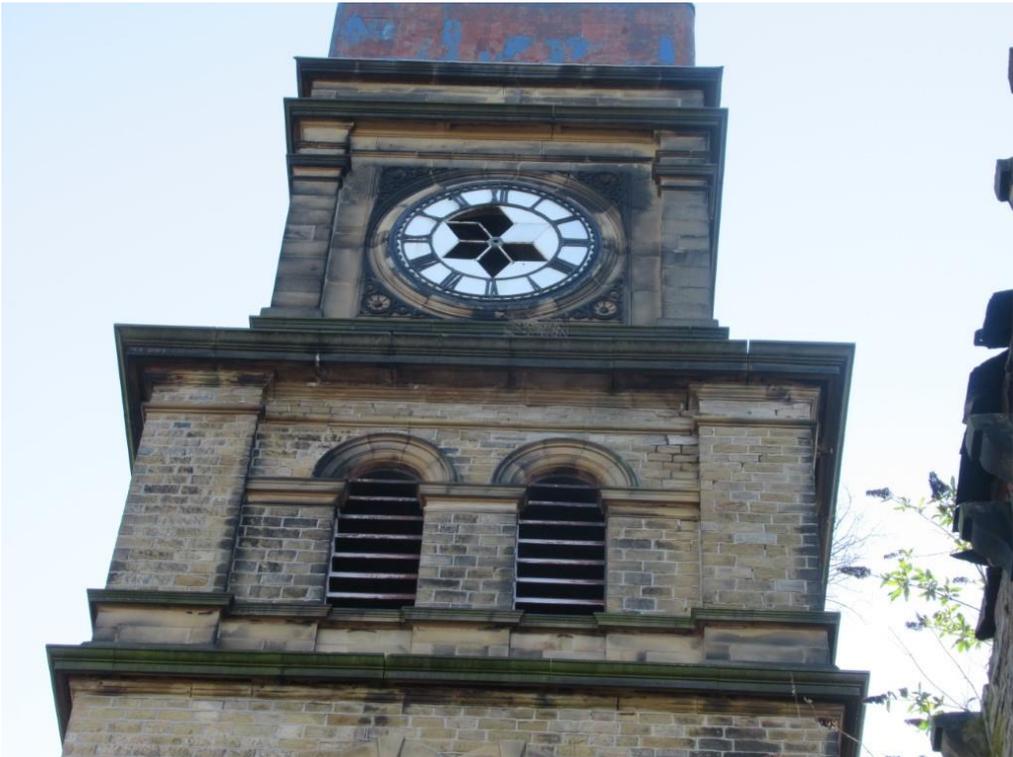
5. This masonry movement has resulted in the opening up of the joints seen in the corbelled stonework courses at all areas, and also the bedded stonework having vertically cracking near the corners.

Photo 4 – Enlarged photo of top storey and 2 levels of corbelled stonework showing opening up of joints.

2. The corbelled level of stonework seen just above the level of the bell louvers need further direct restraint from the top down by installing dog cramps full perimeter to prevent the upper stone large corbels moving out.

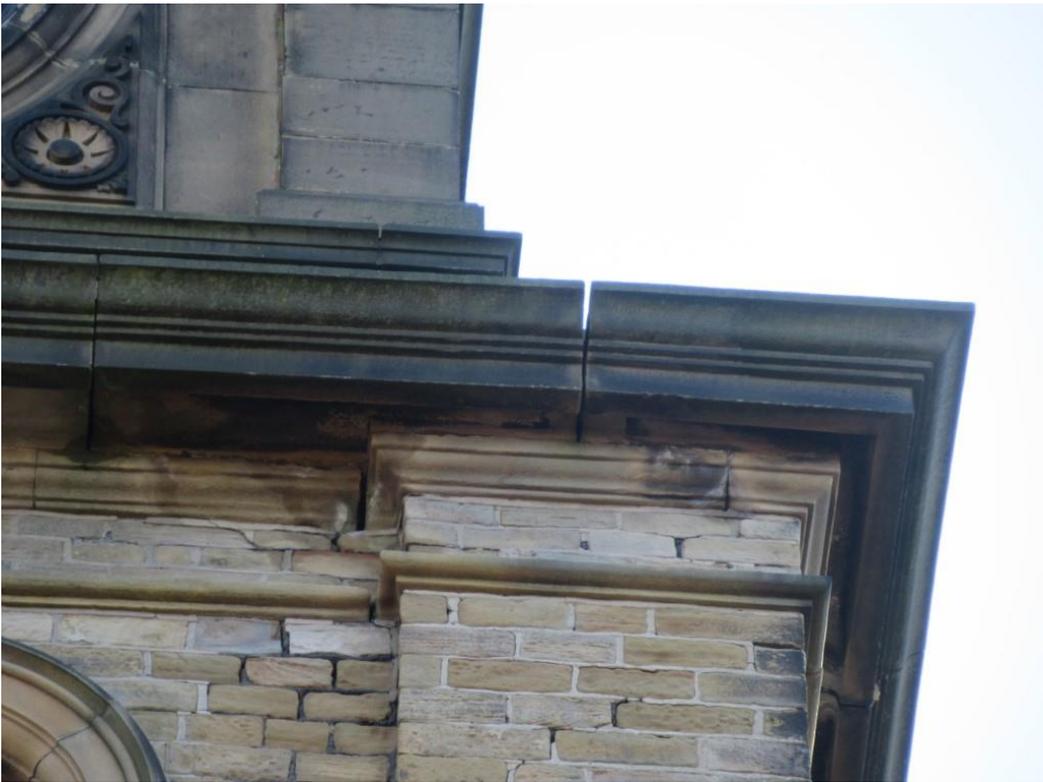
Photo 5 – Upper open joint to right hand side corbelled stonework – Also wide joints to bedded stonework, adjacent corner pillar.

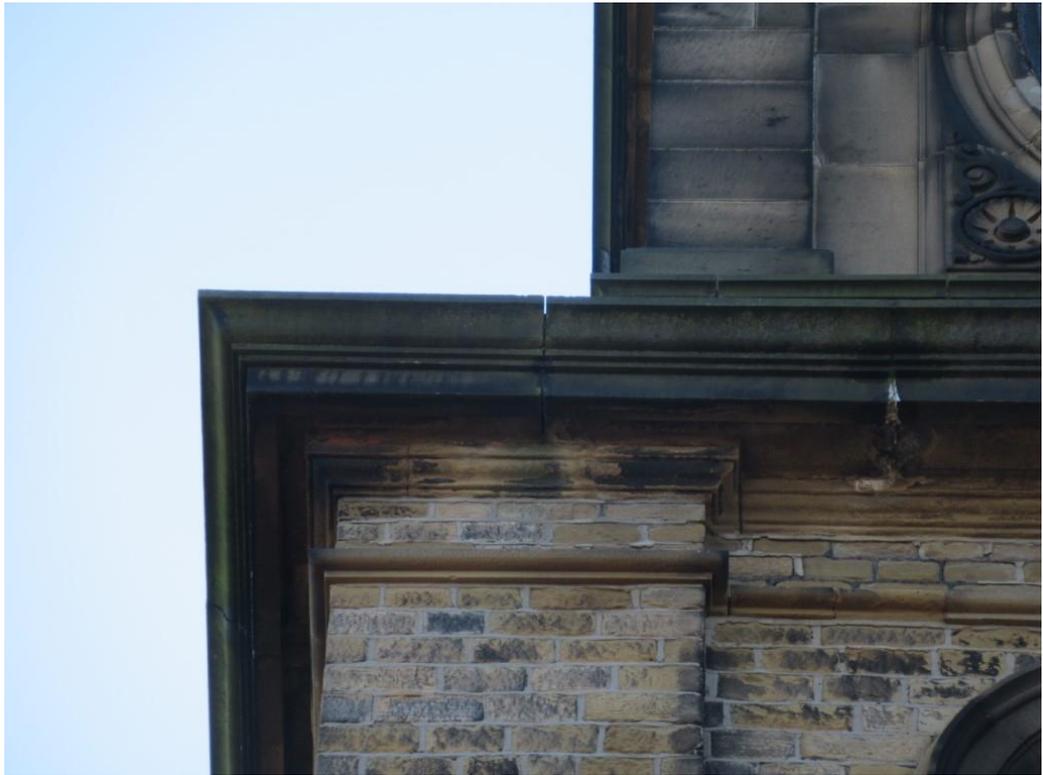
Photo 6 – Left hand side, showing further open corbelled stonework joints.

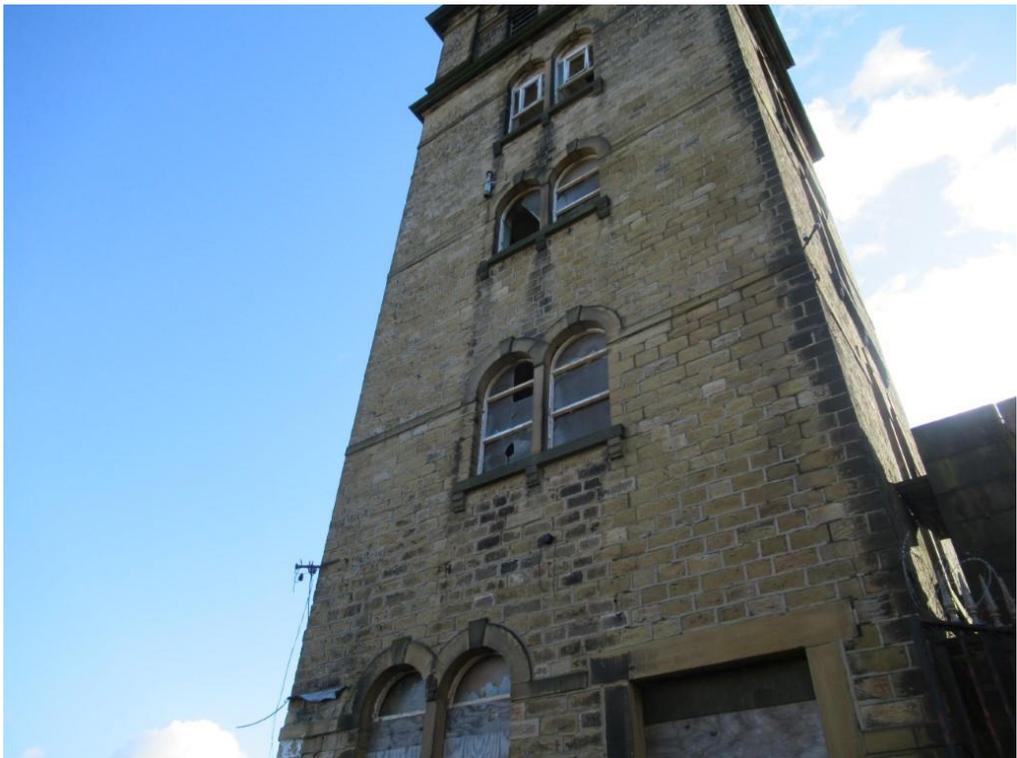
8. There are extensive areas of original pointing that has become dislodged and has fallen off.

Photo 7 – Areas of strap patch re- pointing required.

3. There are extensive areas on all elevations that need re-pointing. This should be undertaken by carefully chipping out and raking out the joints to a depth of 20mm to allow new strap pointing to be installed. The pointing mix should be agreed with Kirklees Listed Building Department as, indeed, all aspects of the refurbishment works.

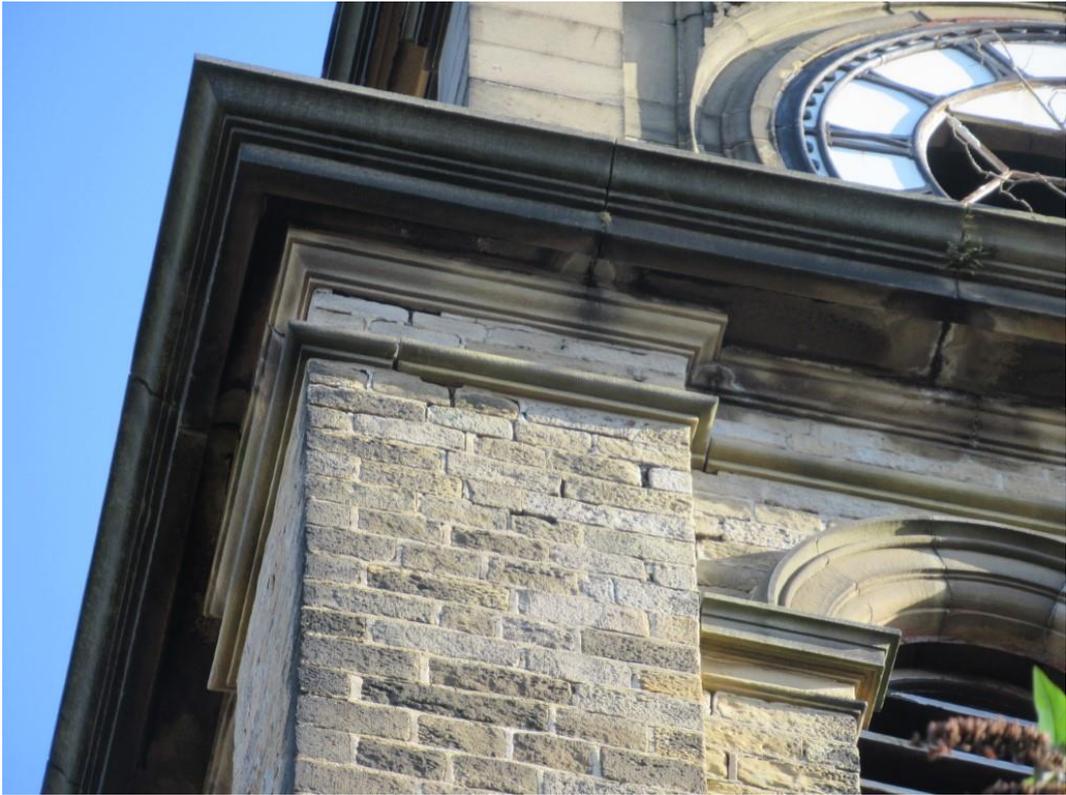
Photo 9 – Left hand side general open joints to walling stone at corner.

1. The outward movement of the tower stonework at the corners needs an internal restraint system installing. This should take the form of a galvanised steel ring beam. This should be resin fixed to the inner face of the external walls with stainless steel threaded bars resin fixed through the inner brickwork to the outer stonework. The development of the design and drawings after a detailed survey is outside the scope of this present report.

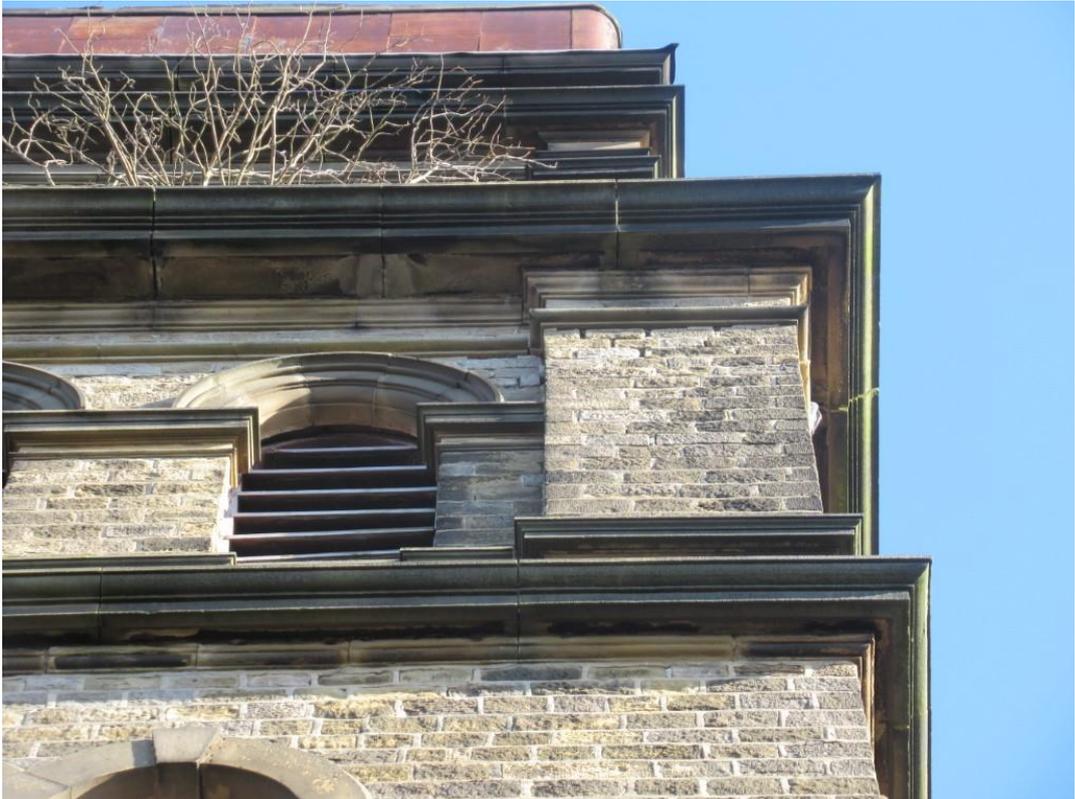
Photo 10 – Further open joints to corbelled stonework, above louvered bell tower opening.

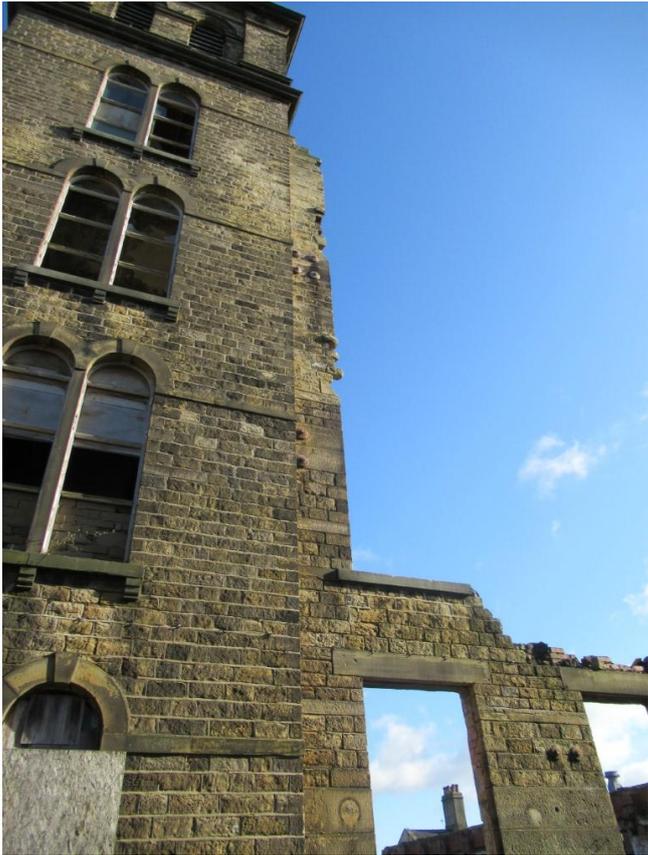
Photo 11 – Right hand side where the historical 4 storey high mill building, was previously attached. **NB** – Corner of the clock tower is perfectly plumb.

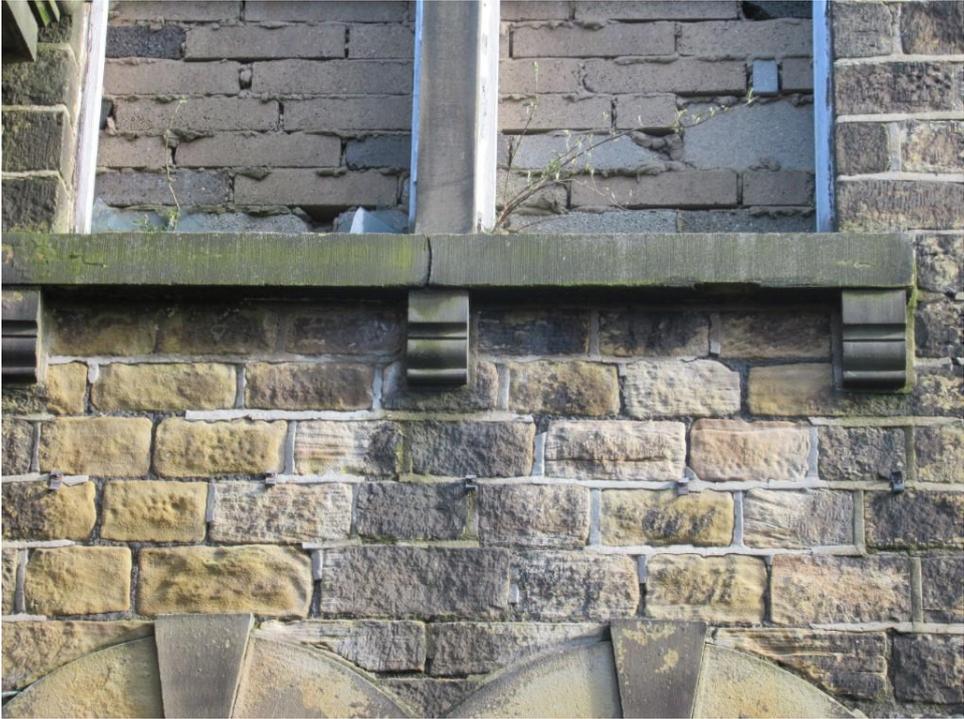
7. Movement of the stonework has resulted in some sill stones becoming cracked. These are of little structural concern. Similarly occasional lintels have cracked, some caused by the 2016 fire. Those where seen are of little structural concern.

Photo 12 – First floor sill stone – Cracking at centre.
NB, Localised loss of strap pointing.

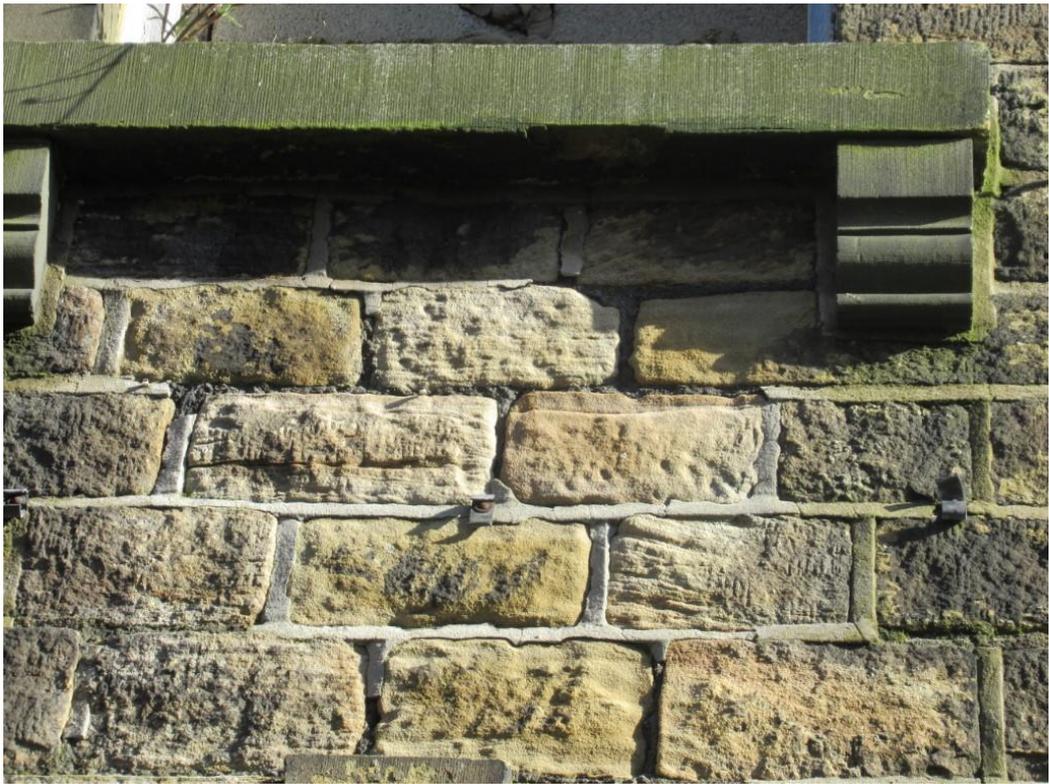
Photo 13 – Enlarged view of first floor sill stone to south west elevation.

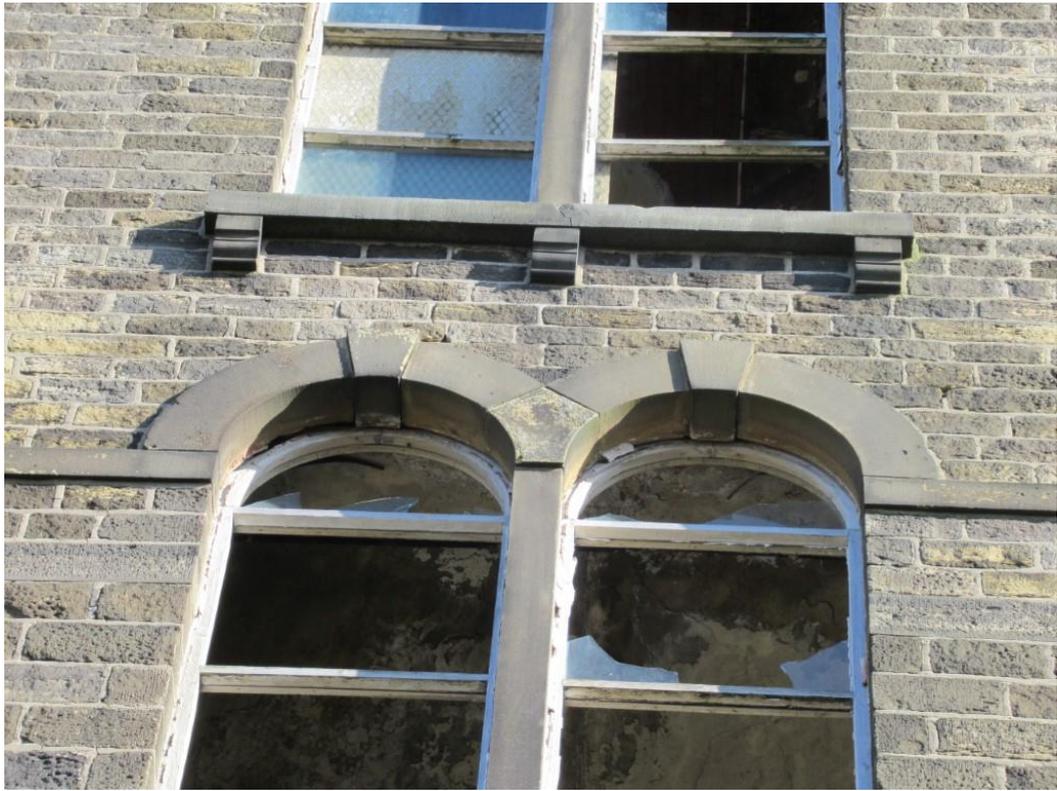
Photo 14 – General view of crack to third floor window sill.

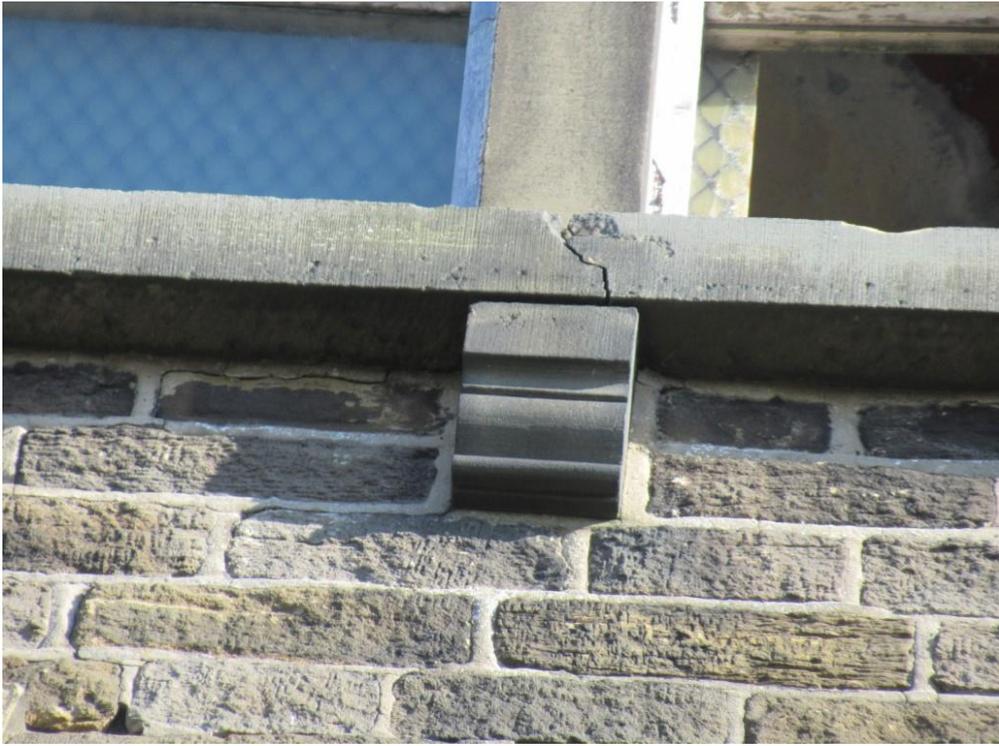
Photo 15 – Enlarged view of crack to third floor window sill.

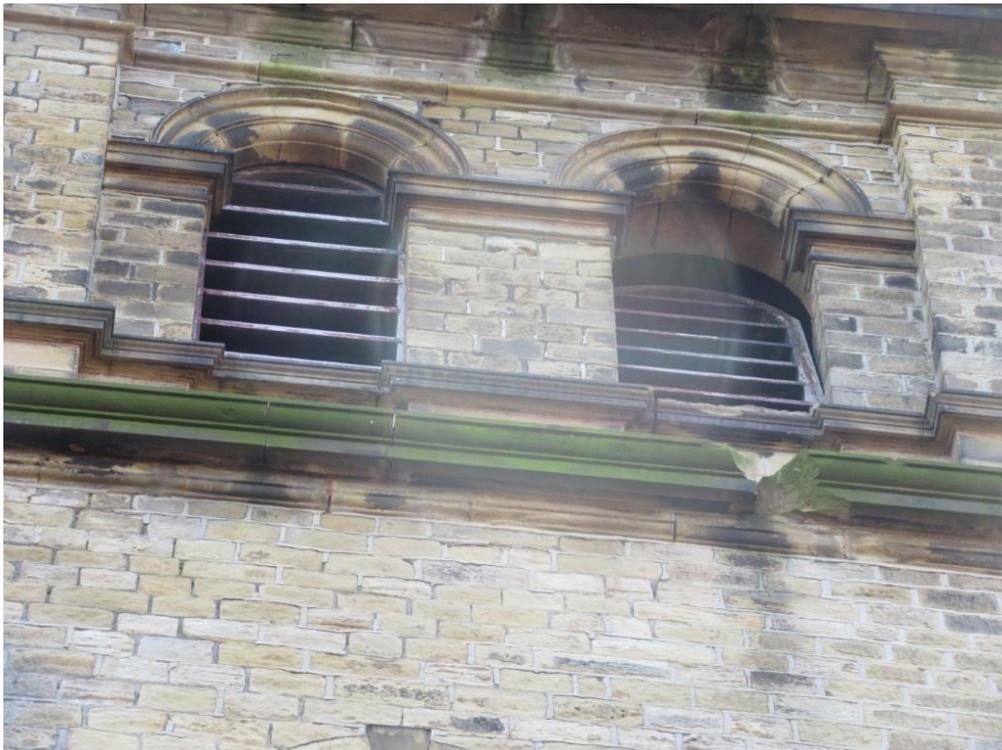
Photo – 16 – Enlarged view of fourth floor, showing impact damage to the stone corbelled course. **NB** Smoke damage as a result of the relatively recent fire.

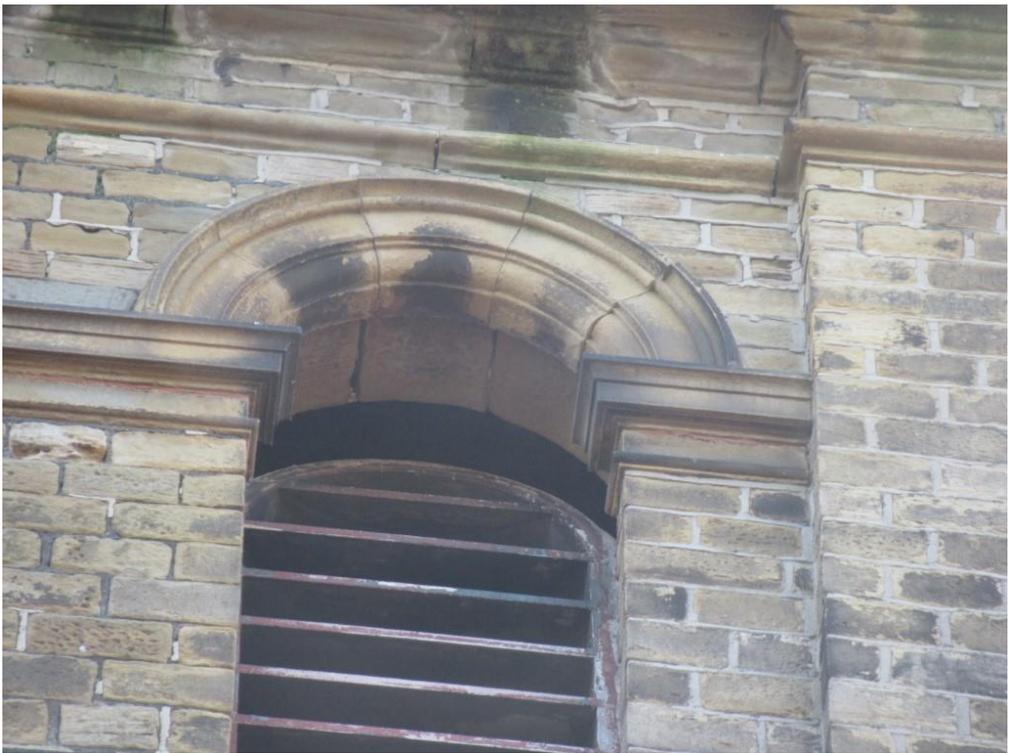
6. As a result of the corners moving out, the upper stone arches have opened up causing movement of the individual stone blocks, and some of them dropping down.

Photo 17 – Displaced corbelled stonework to arch, as right hand corner stone pillar has moved out. Timber louvre has become displaced.

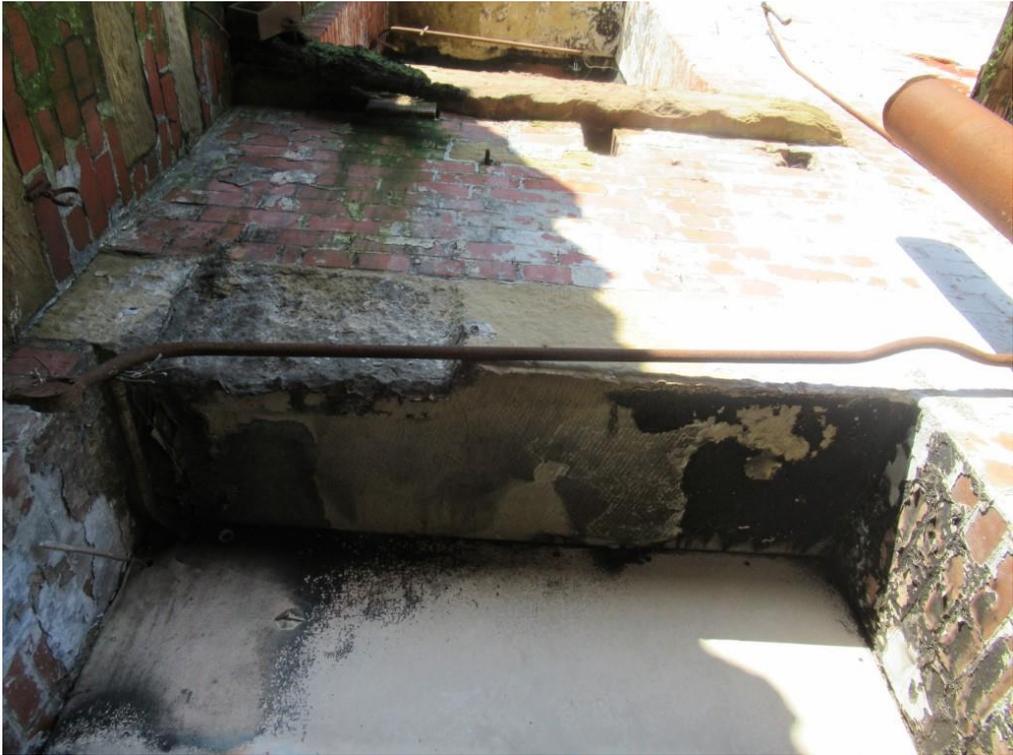
Photo 18 – Ground floor lintel – fire damaged.

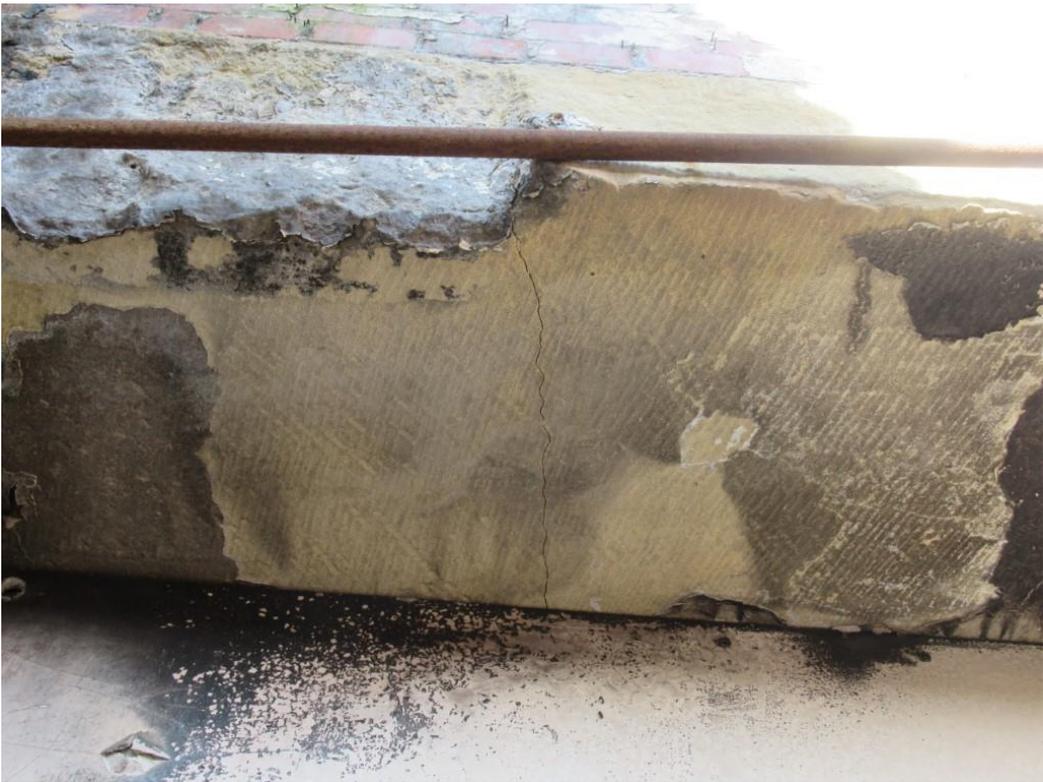
Photo 19 – Enlarged view of crack to the underside of the stone lintel – caused by fire damage, due to the intensity of the heat.

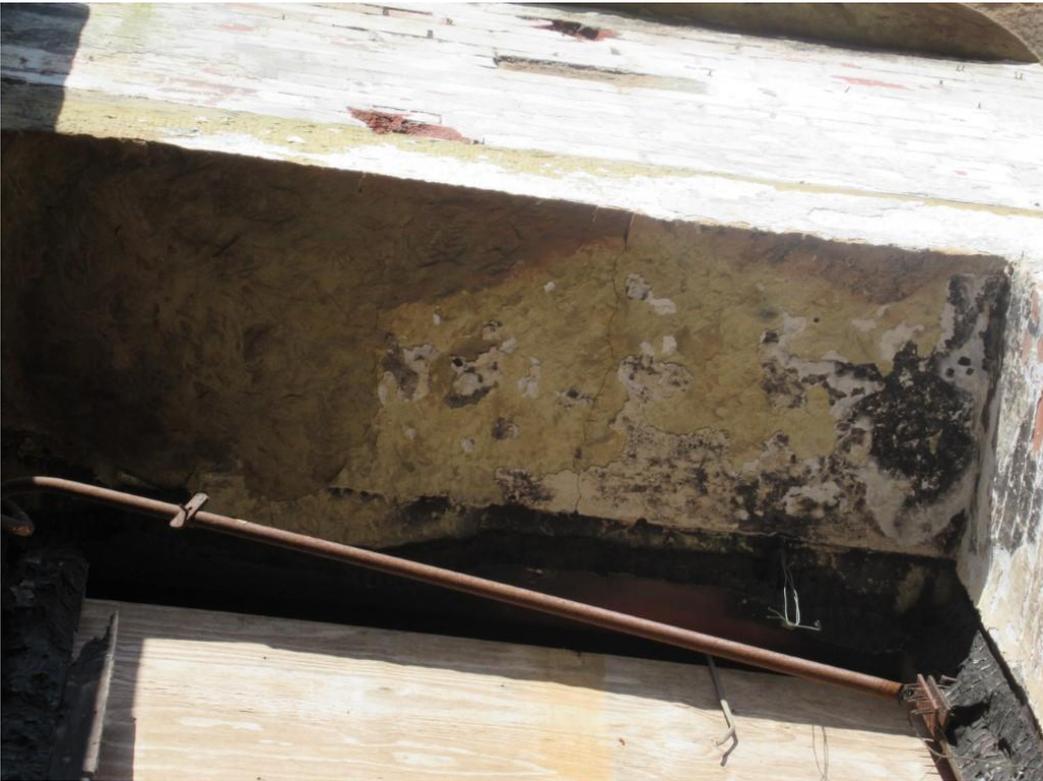
Photo 20 – Similar cracking to first floor lintel.

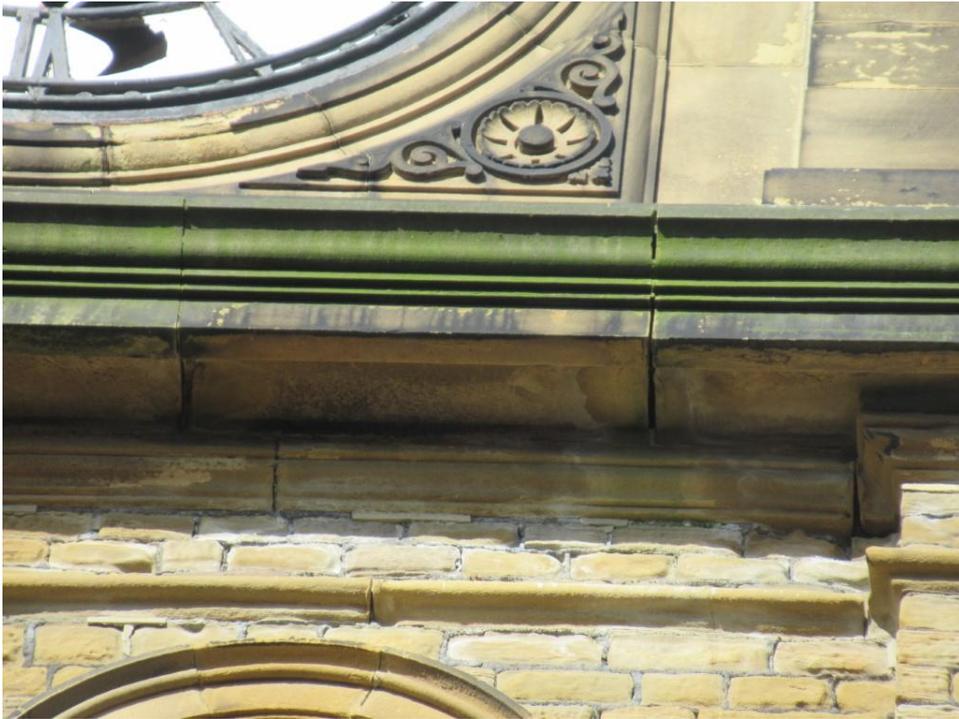
Photo 21 – Opening up of cornice stonework.

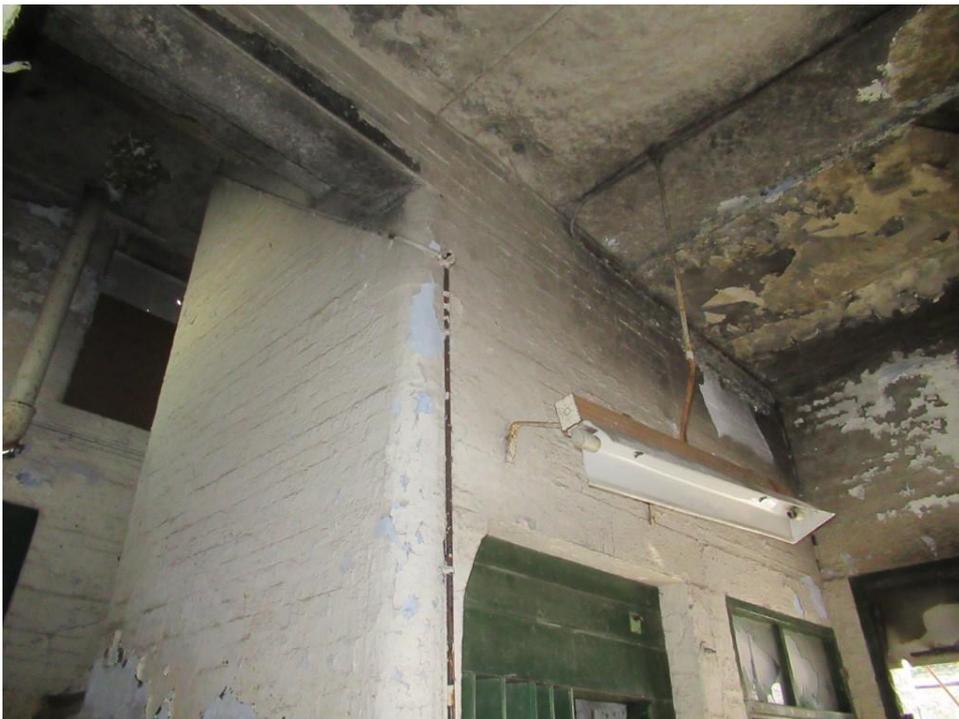
Photo 22 – General internal view of ground floor showing central brickwork core around lift shaft. In excellent condition.

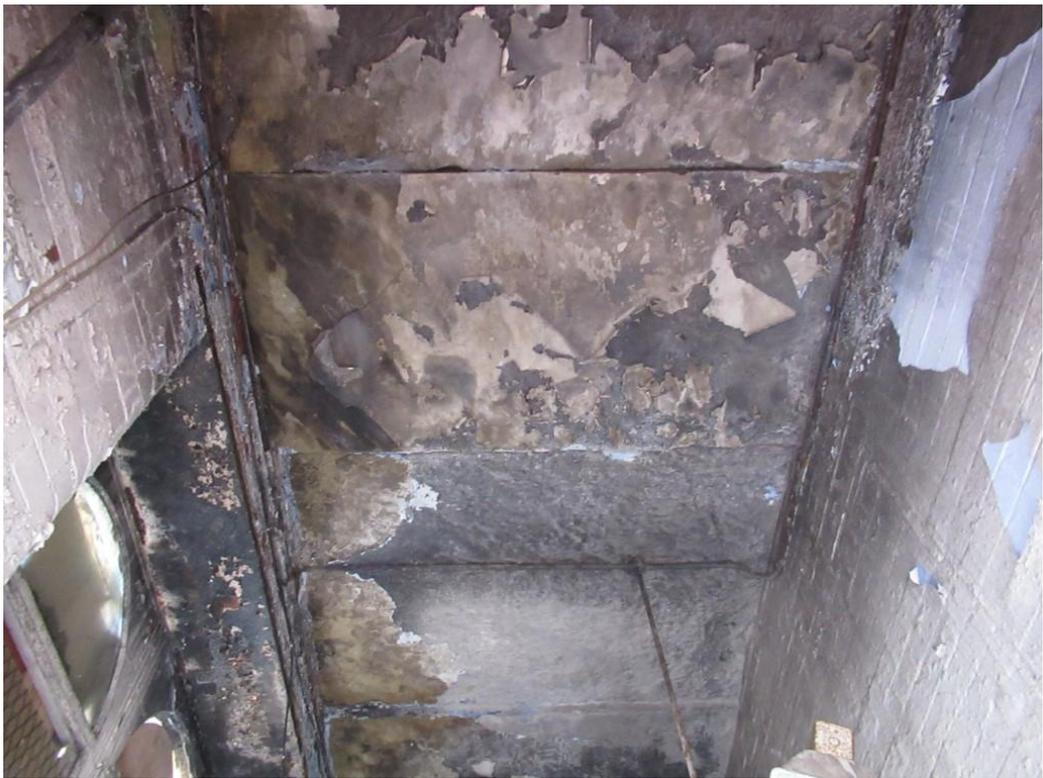
Photo 23 – Underside of fire damaged stone slabs to first floor landing.

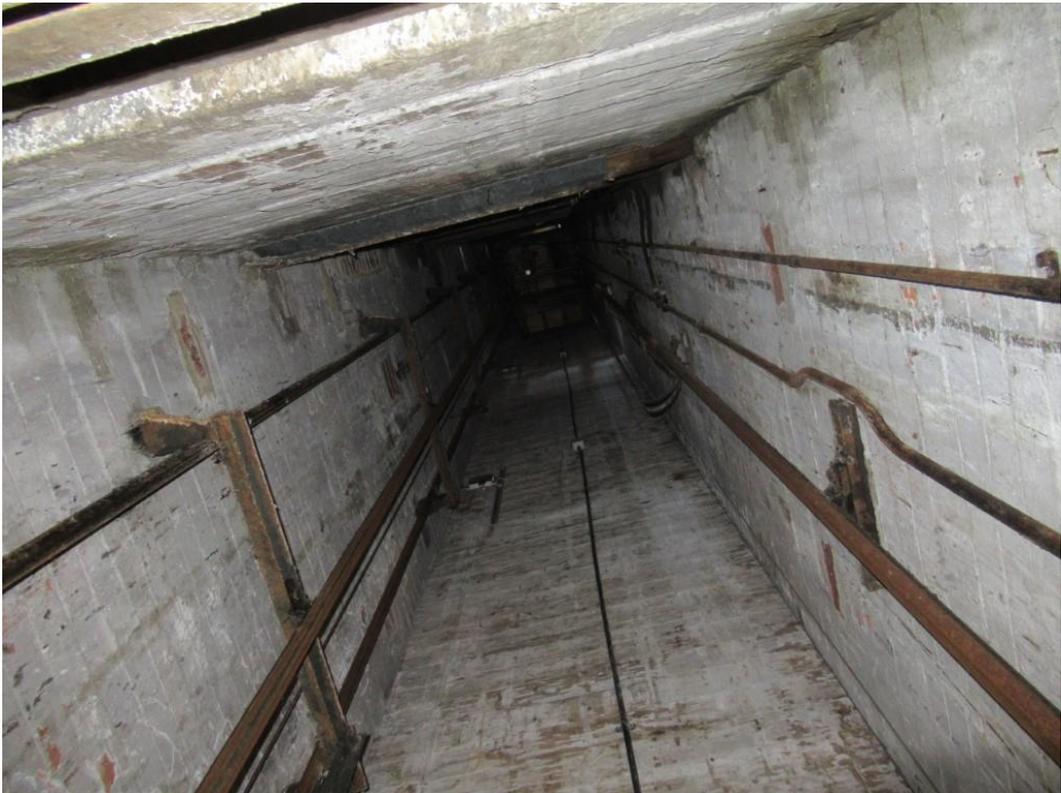
Photo 24 – General view of lift shaft. In excellent condition. All walls plumb.

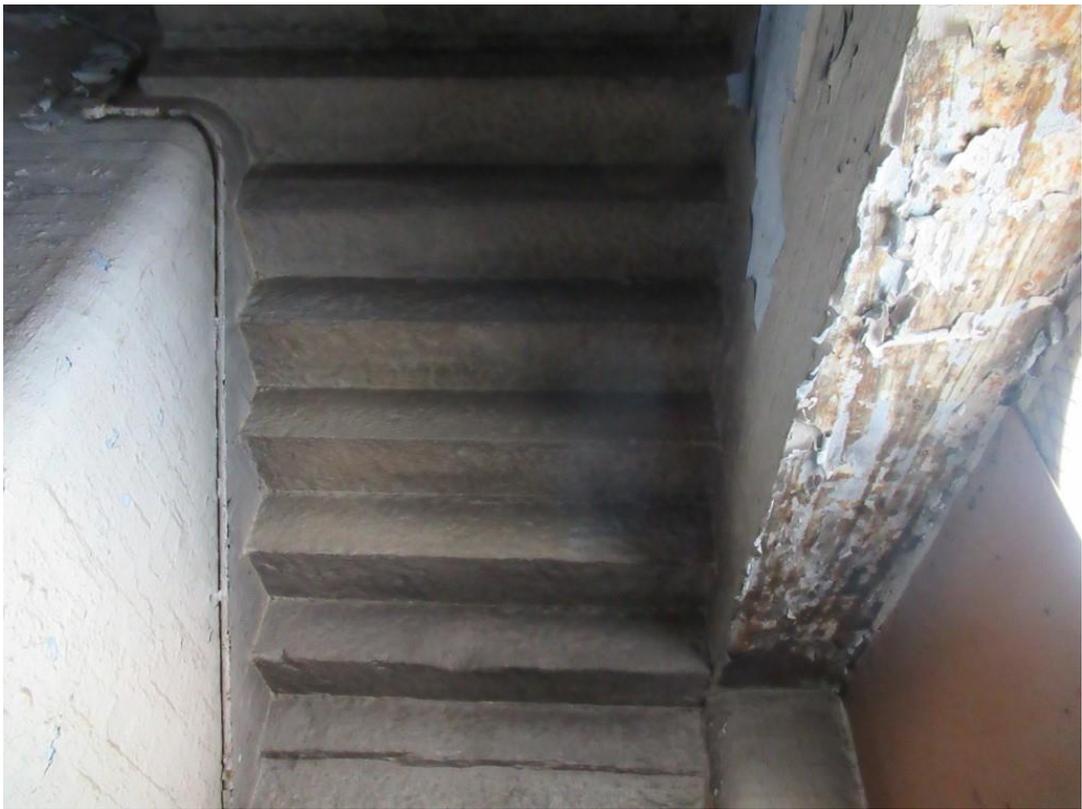
Photo 25 – Underside of staircase above ground floor quarter landing.
Excellent condition.

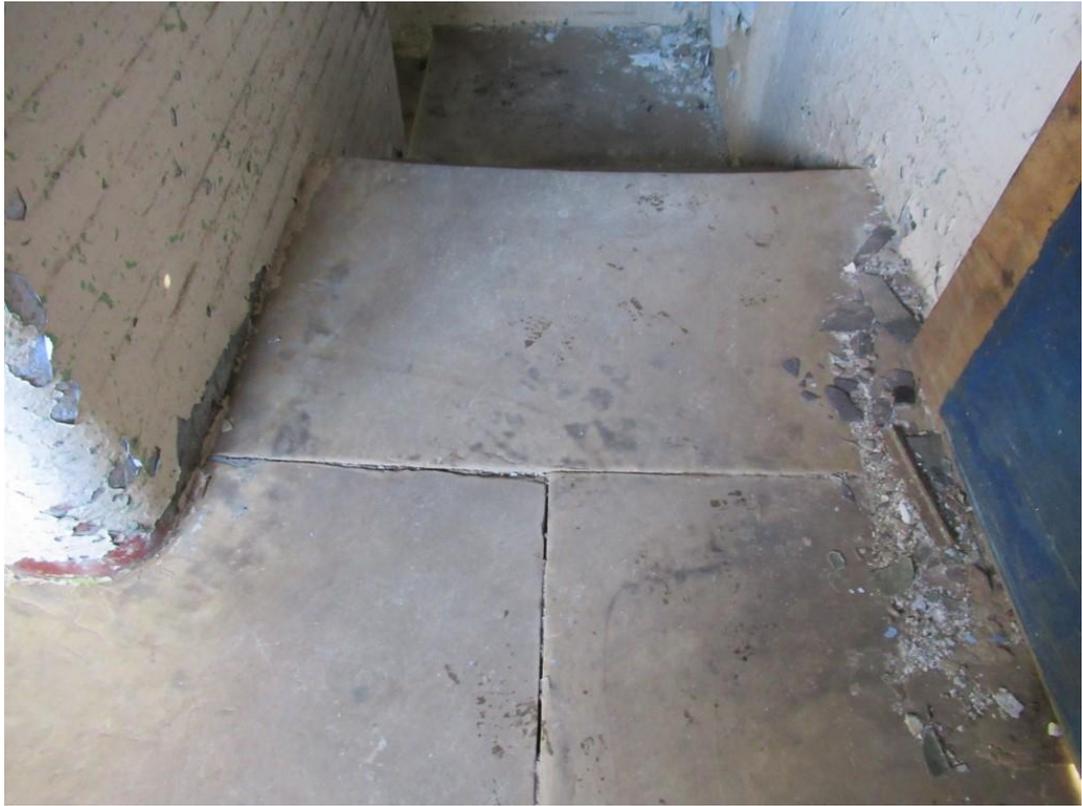
Photo 26 – First floor landing. All in excellent condition.

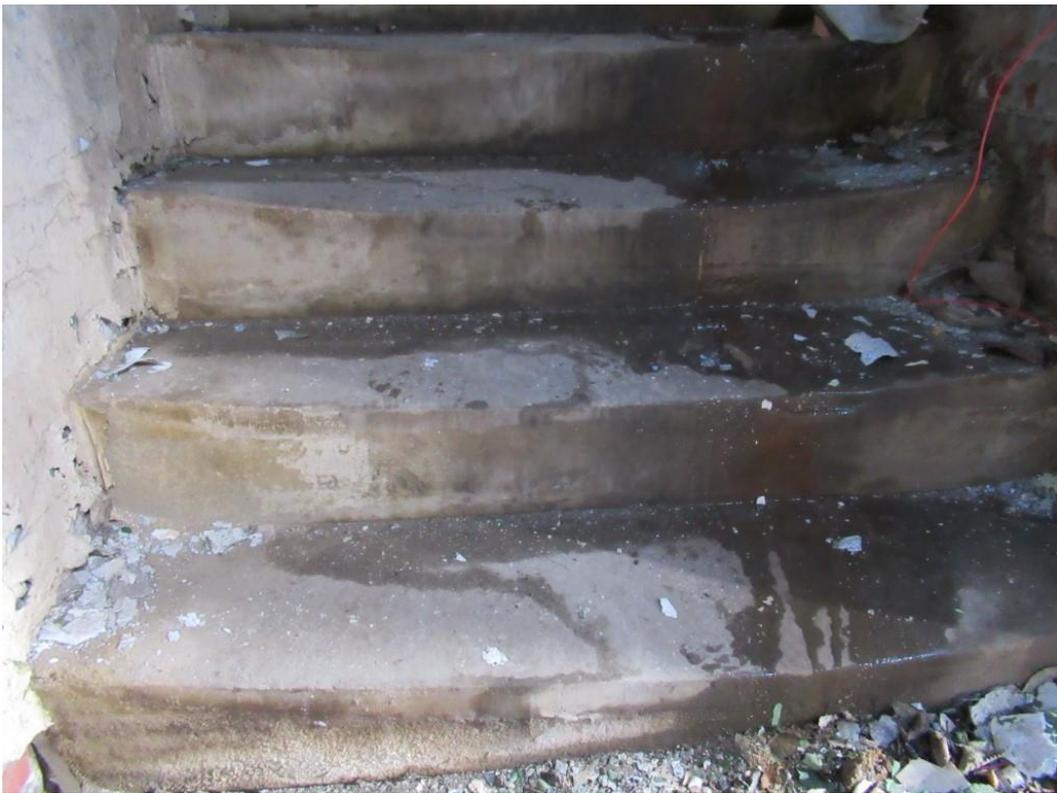
Photo 27 – Worn natural stone staircase flight, measured as 30mm of wear, but otherwise in excellent condition.

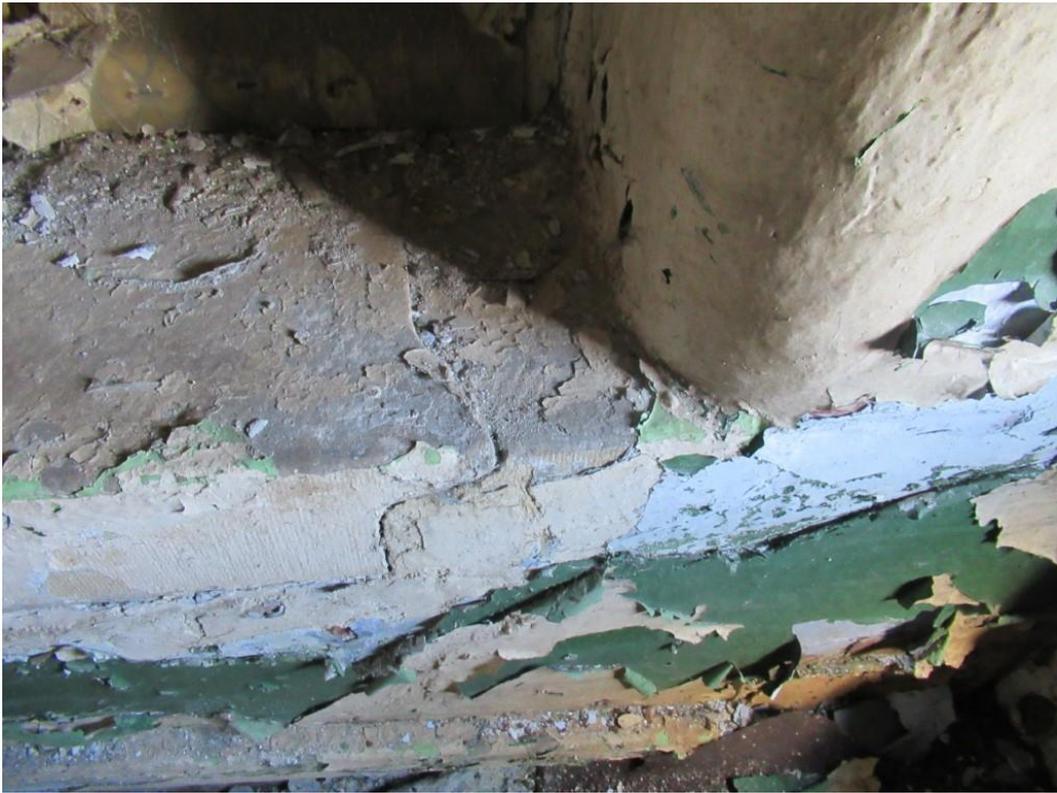
Photo 28 – Historical crack to window sill stone at first floor.

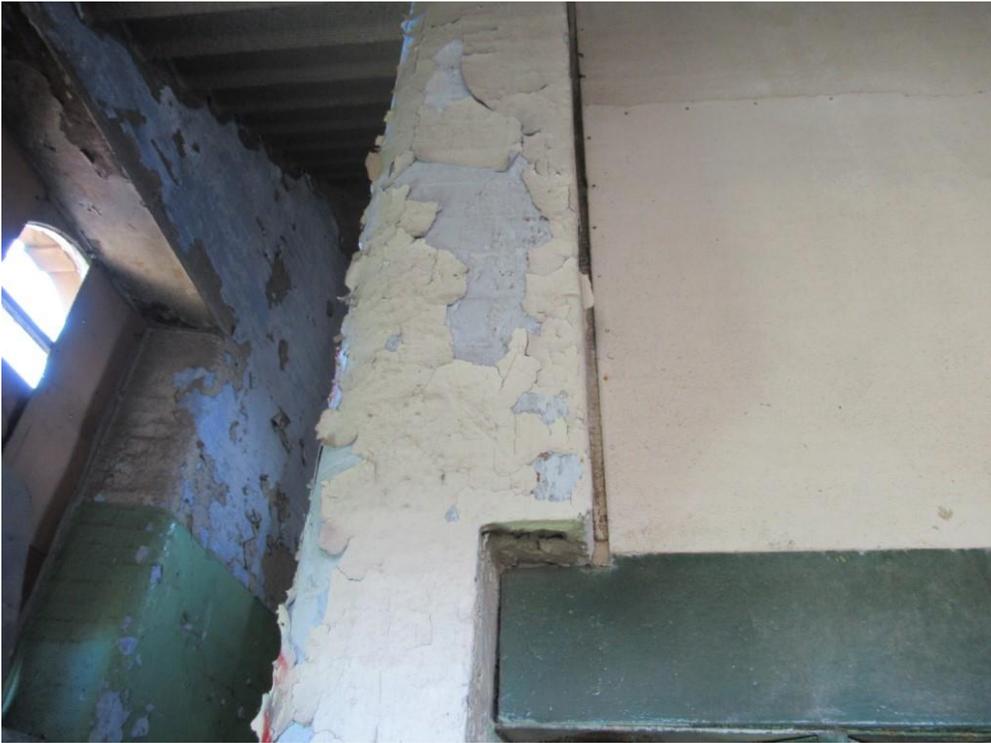
Photo 29 – Historical alteration to the width of the lift shaft. Typical at each level. Possibly required due to concertina action of retro fit lift doors.

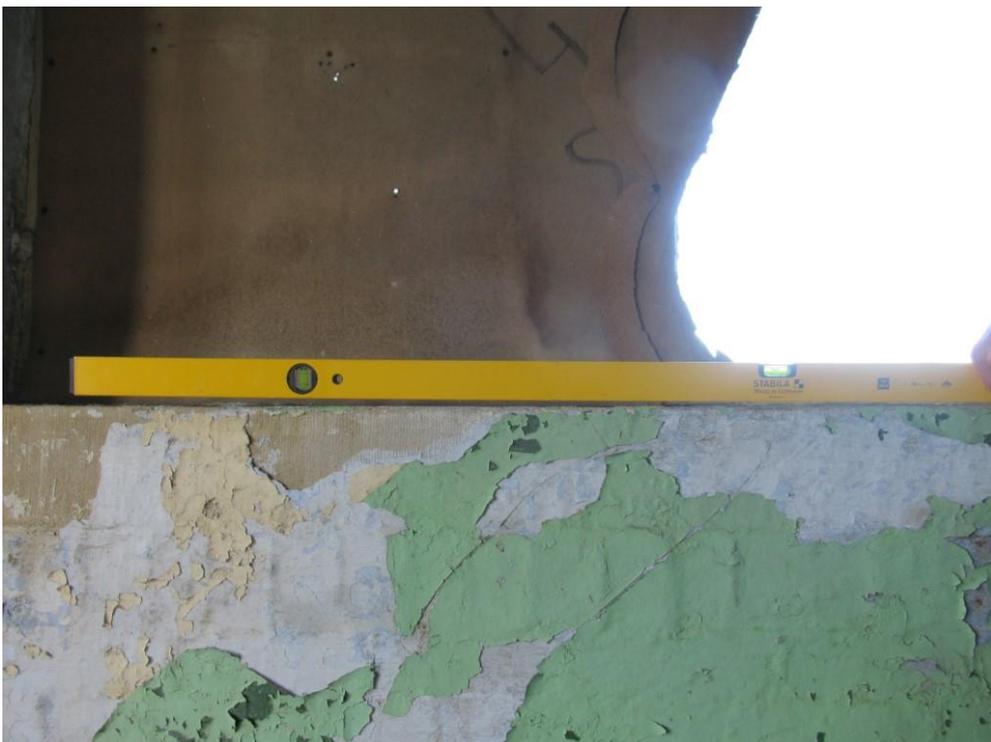
Photo 30 – Third floor sill stone. Possibly set incorrectly as no signs anywhere of any settlement or distortion of the clock tower building.
NB, Levels were checked to the lift shaft brickwork and clock tower verticality in numerous locations with a 1.8m long spirit level and ALL found to be plumb with no lean.

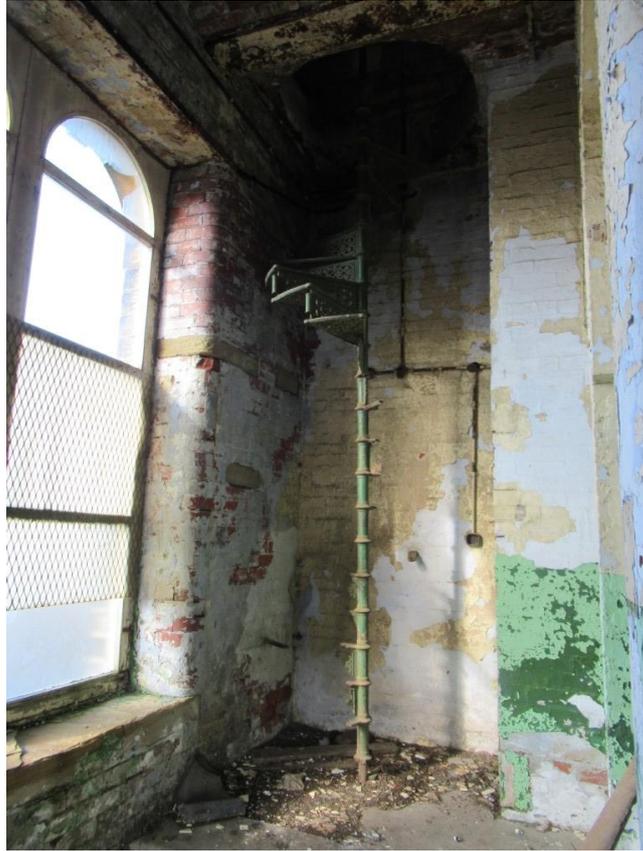
Photo 31 – Remains of the historical cast iron spiral staircase to the bell tower level.

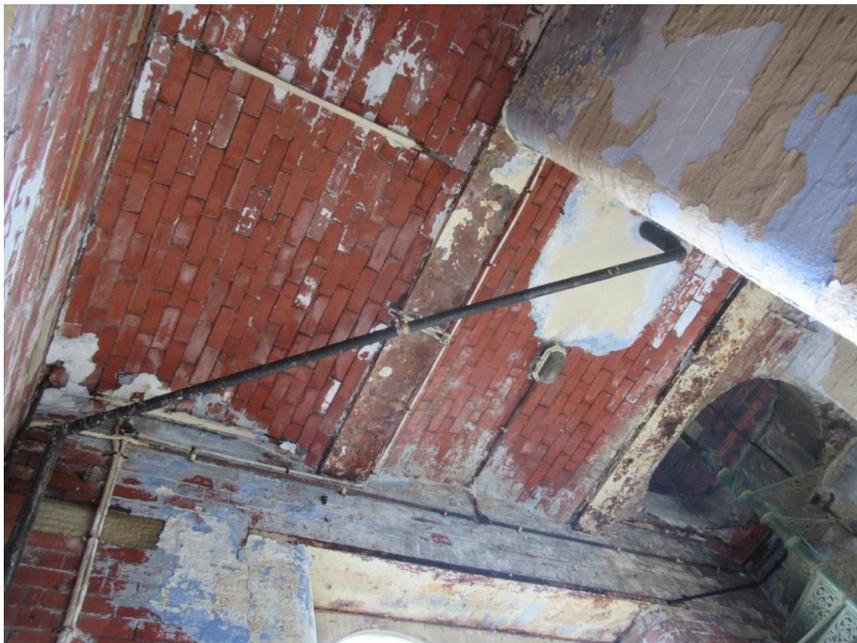
Photo 32 – Barrel vaulted ceiling to the third floor level, showing access hole for the spiral staircase to bell tower. Barrel vaulted brickwork is supported by cast iron beams with the rods present to prevent spread. Mild surface corrosion noted to the beams but otherwise in excellent condition.
