LIMITED CONDITIONAL STRUCTURAL REPORT

Project	Newsome Clock Tower, Newsome Mills, Ruth Street, Newsome, Huddersfield, HD4 6JF
Project Number	2020/083
Date	27th February 2020

Structural Conditional Report on Newsome Clock Tower, Newsome Mills, Ruth Street, Newsome, Huddersfield, HD4 6JF

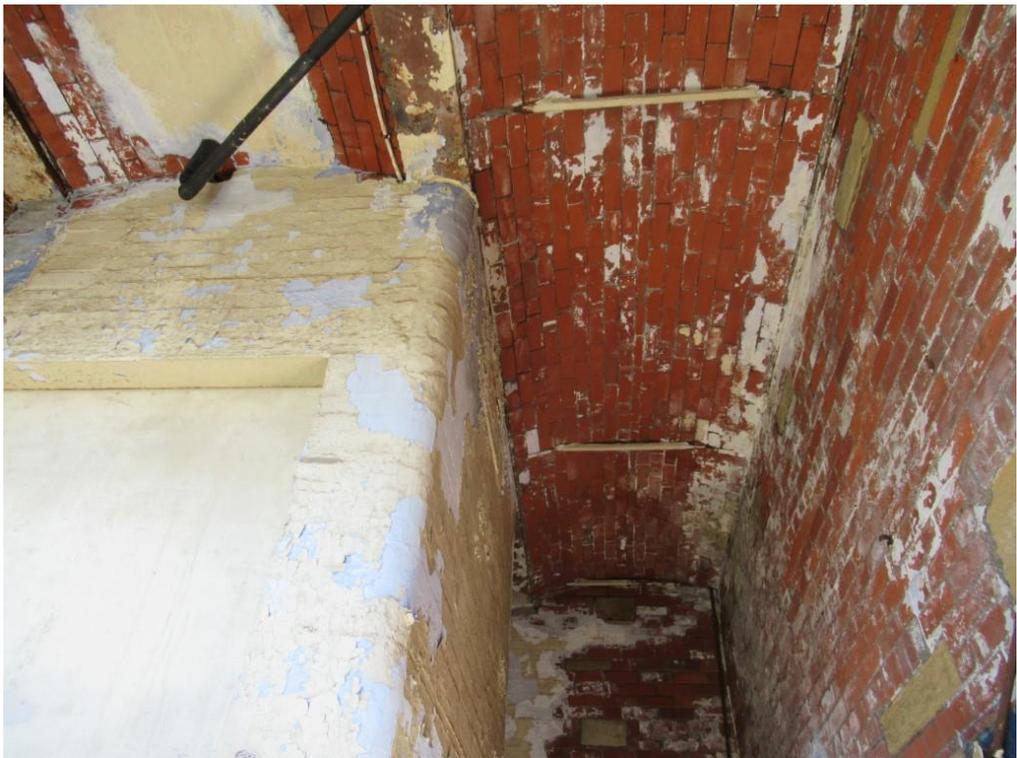
Photo 33 – Further view of the barrel vaulted ceiling, again in excellent condition.
