# **Geo-environmental Ground Investigation Report**

**NEWSOME MILLS, RUTH STREET,  
HUDDERSFIELD**

**PANORAMA LIVING**

**E19/7413/R001**

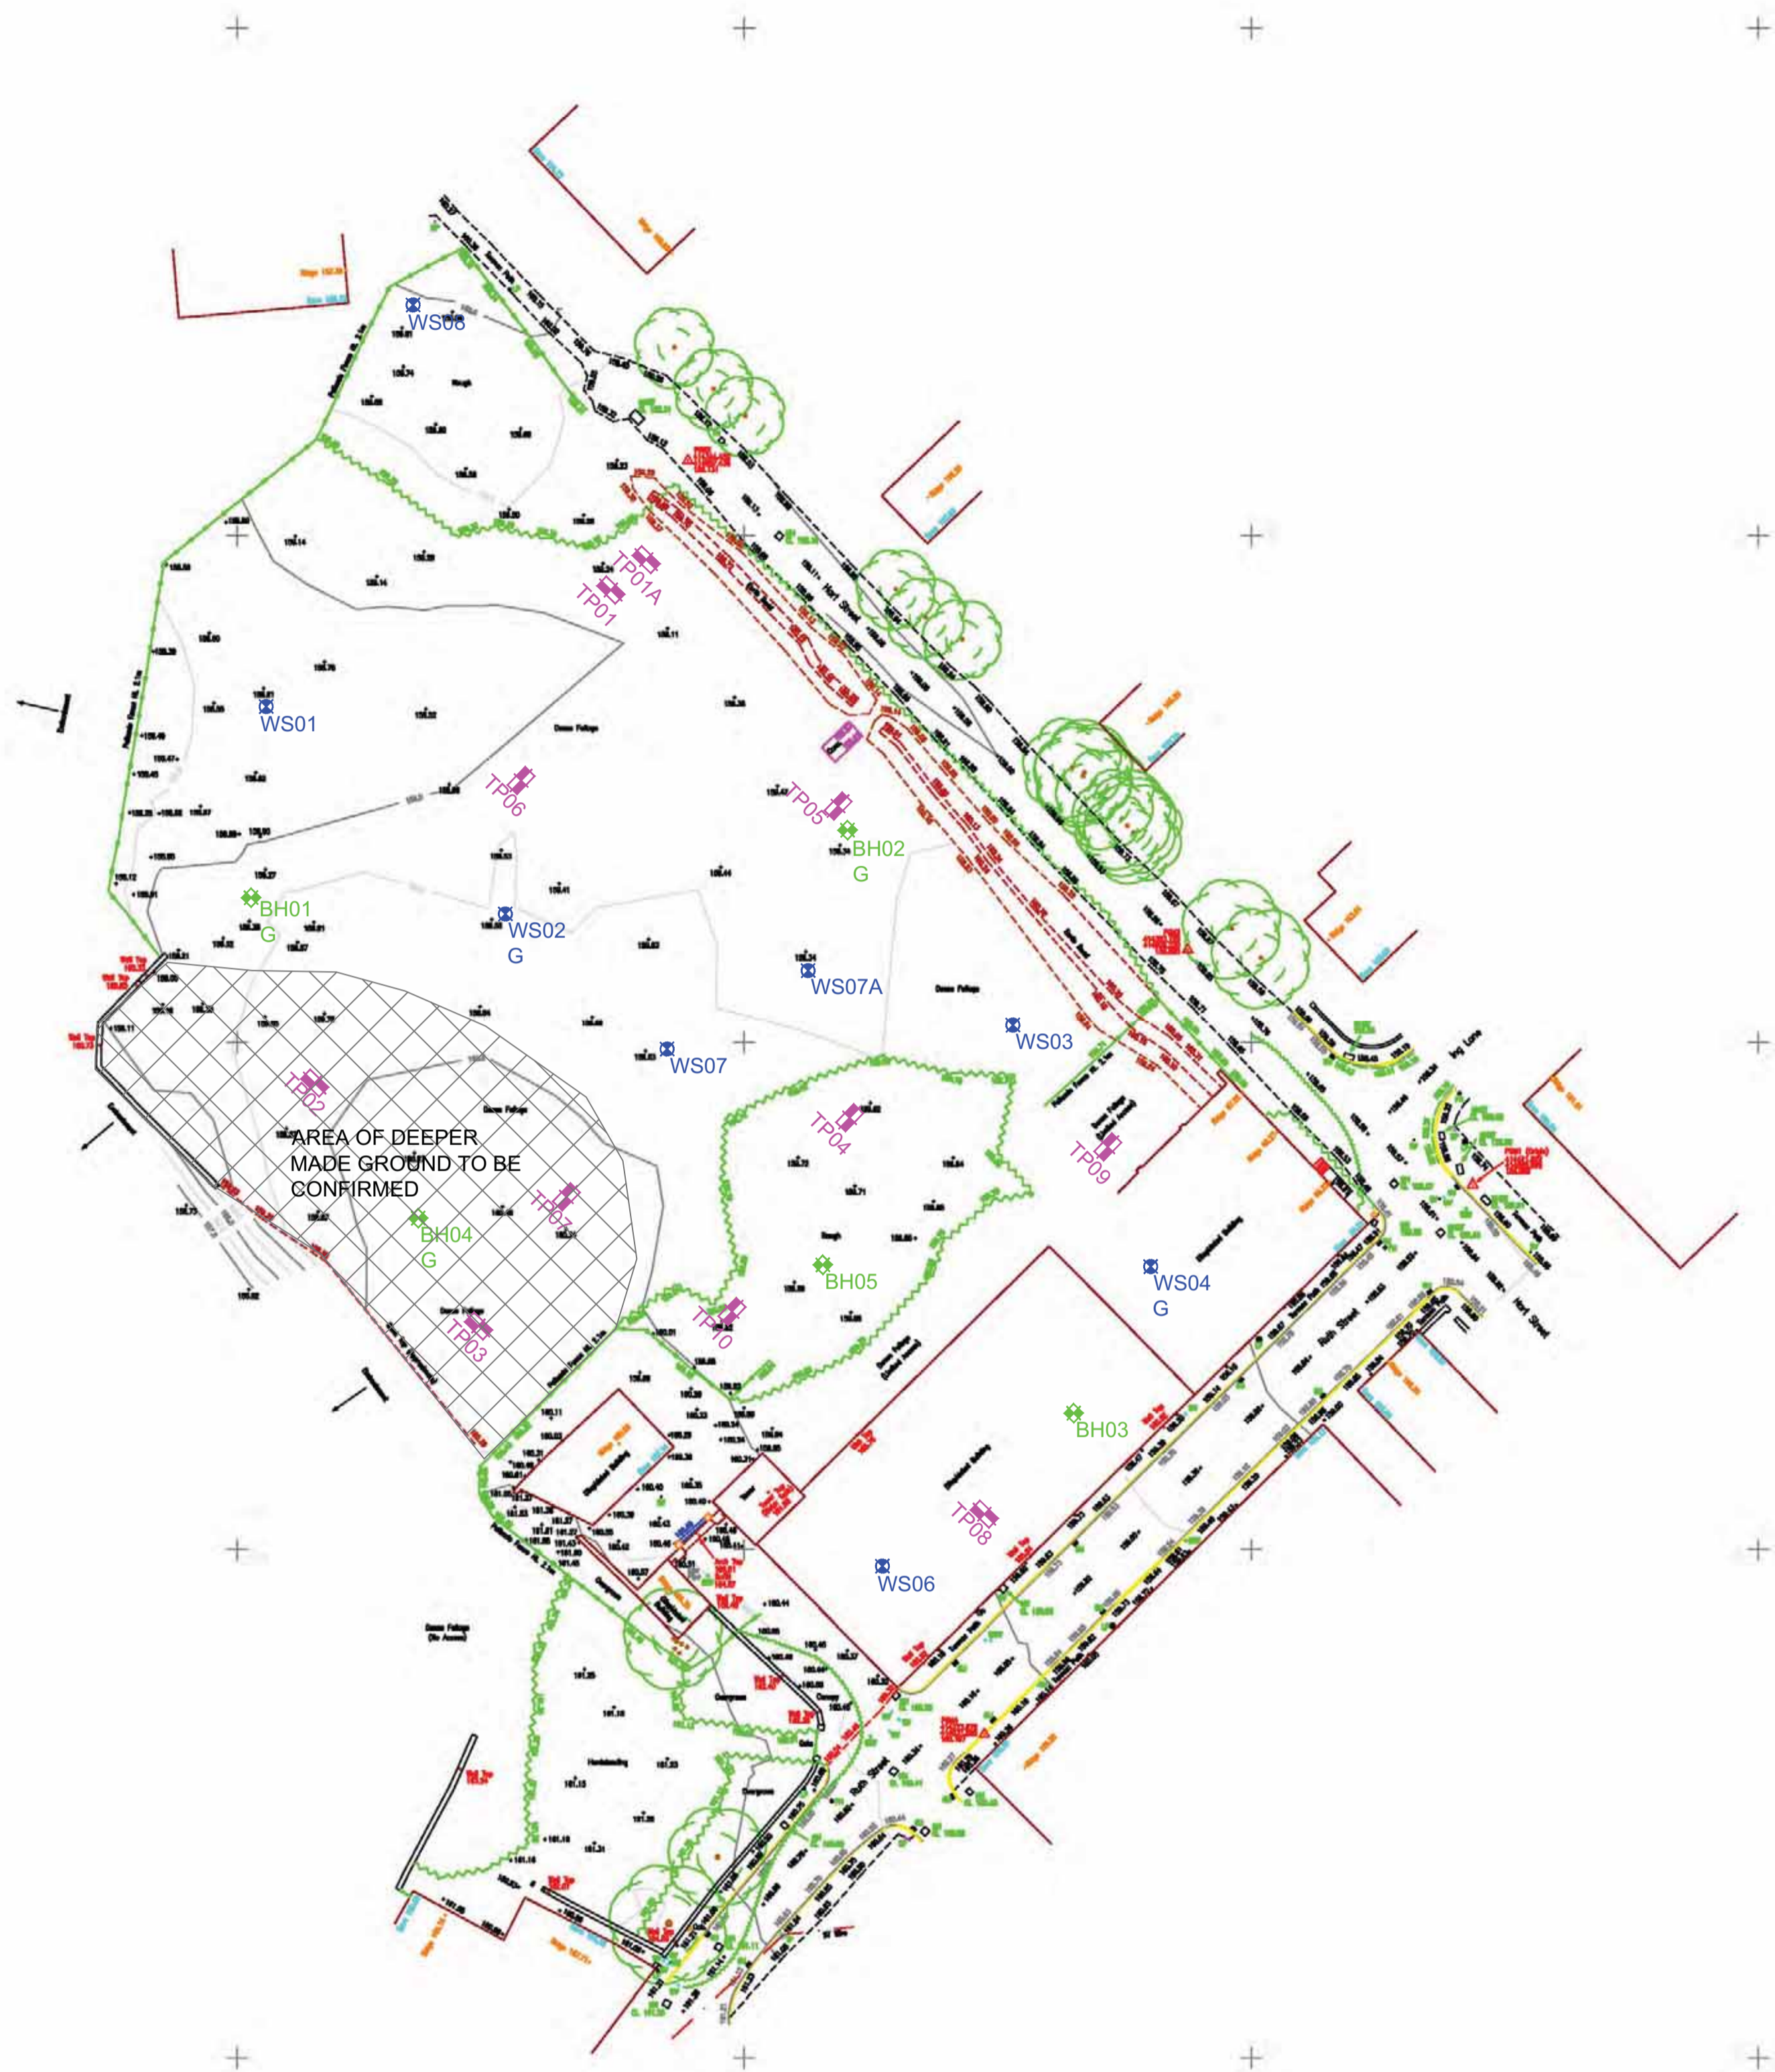
Dwg No.  
E19/7413/03

10.1.3.1 The ground investigation proved up to 4.5m of very loosely compacted demolition material in the west of the site. The made ground material was variable in nature, including large sections of concrete and brickwork, and in areas was unconsolidated leading to instability within the trial pits in this area. The approximate extent of made ground has been indicated on the site investigation plan in Appendix A.

Trial Pit Location

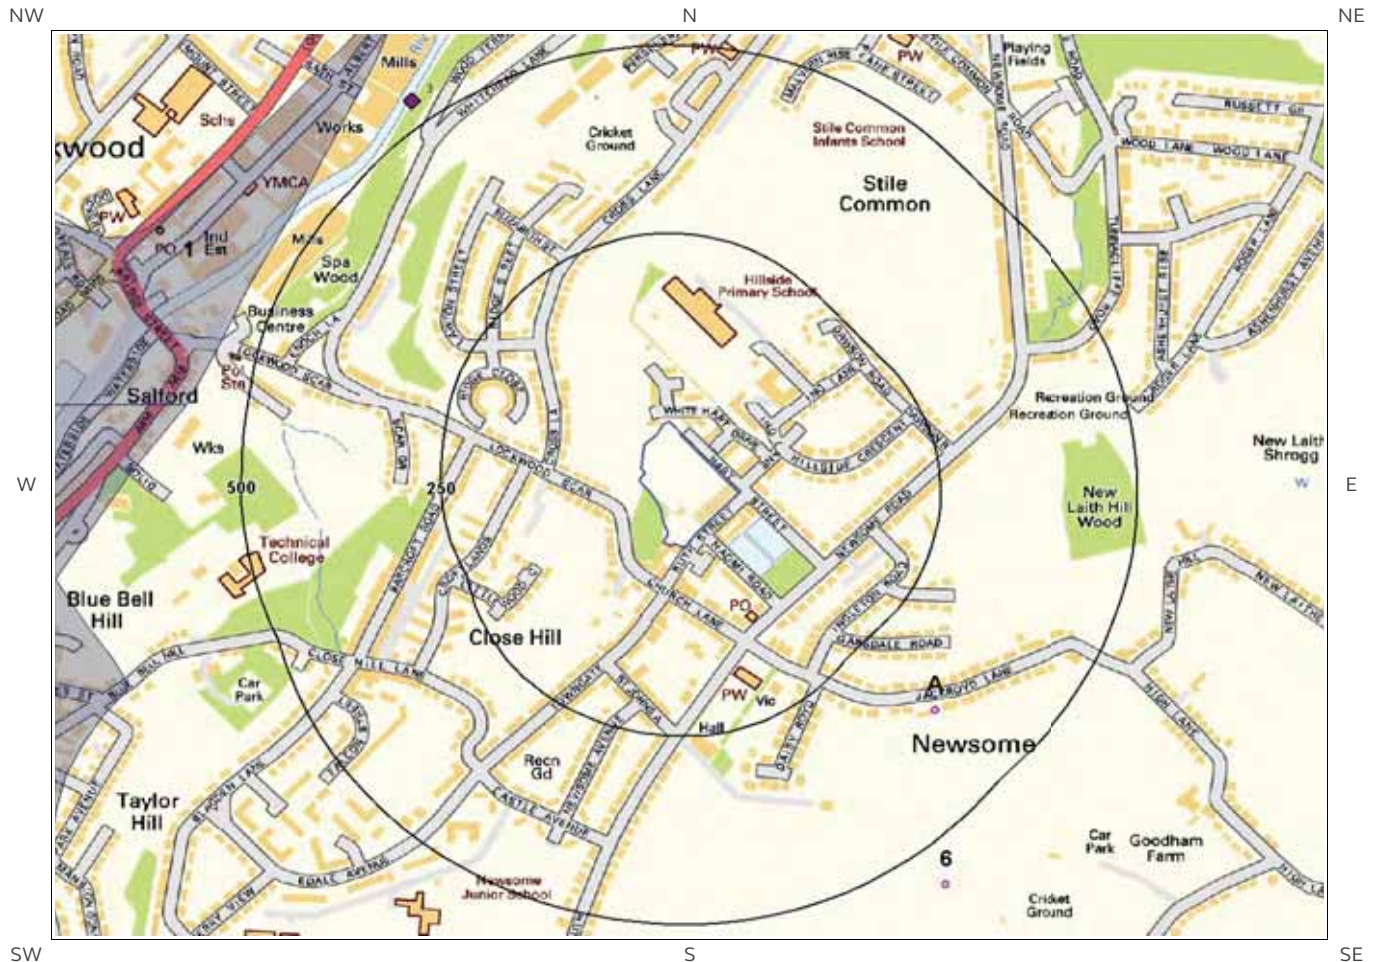
# 5 Mining, Extraction & Natural Cavities map

MINING/QUARRYING	<p>The Coal Authority report states that the property is in a surface area that could be affected by underground mining in 1 seam of coal at 60m to 70m depth, and last worked in 1911. In addition the property is in an area where the Coal Authority believes there is coal at or close to the surface. This coal may have been worked at some time in the past.</p> <p>The boreholes undertaken to 30m depth found no evidence of coal or shallow workings. We would not therefore consider the site to be at risk from mining subsidence.</p>
HYDROLOGY	<p>The nearest recorded surface water features are two mill ponds 50m south east of the site.</p> <p>The site is not in an EA designated flood zone or shown to be at risk of flooding from rivers or the sea.</p>

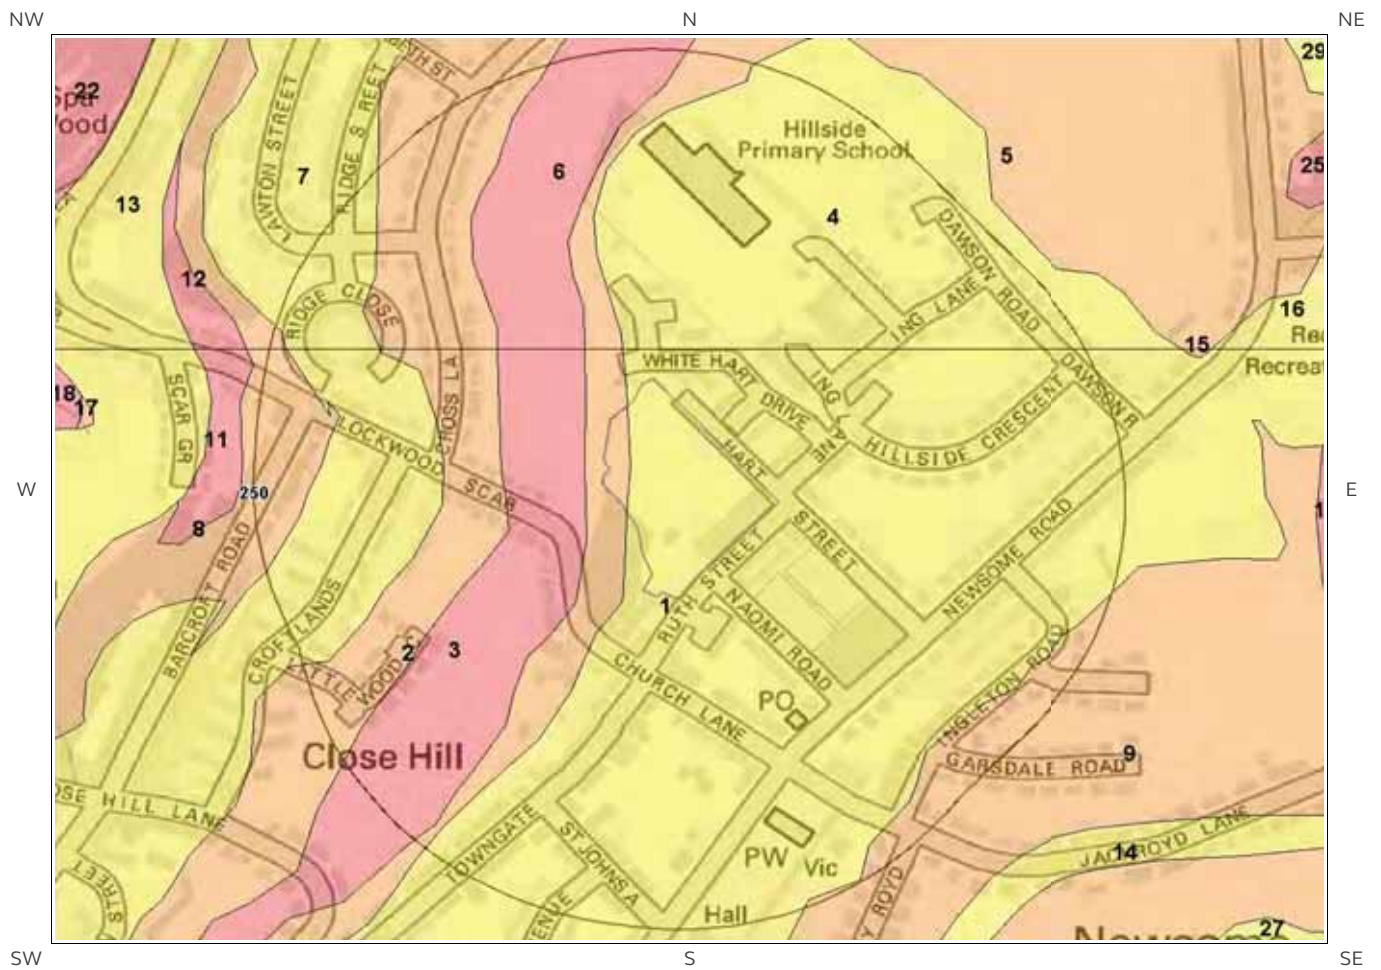
## 6.2 Landslides map

- 4.4 There are no fault lines shown in the vicinity of the site.
- 4.5 A moderate risk of landslides is noted for the site due to the steep banking adjacent the north western boundary.
